Robotic Underwater Decontamination and Robotic Inspection Services

Presented by Javier Banuelos

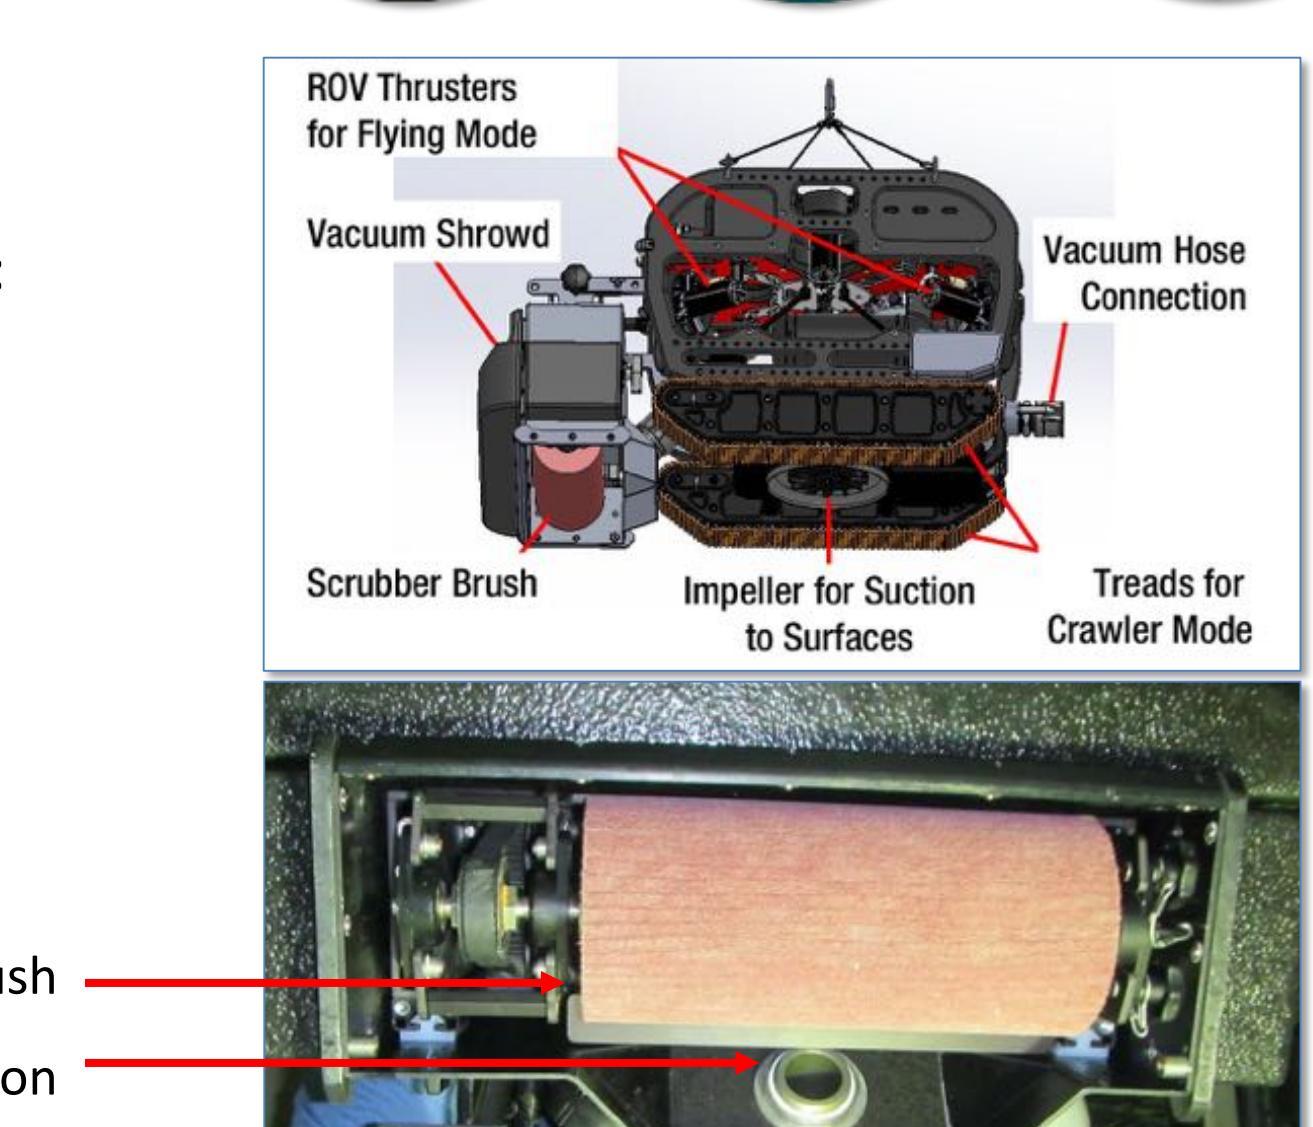
- Hybrid ROV-crawler platform
- ROV mode vectored and vertical thrusters provide maneuverability and positioning
- Flow-less vortex generator for adhering to all surfaces:
 - Flat
 - Curved
 - Horizontal / vertical
 - Interferences and seams
- Integrated cleaning system
- Interfaces with filtration system

Scrubber brush

Tri-nuke vacuum suction

- Transitions freely between "flying" and "crawling" modes
- Flow-less vortex generator creates up to 60 lb. of suction force for adhering to surfaces
- Quick retrieval performed from poolside or platform

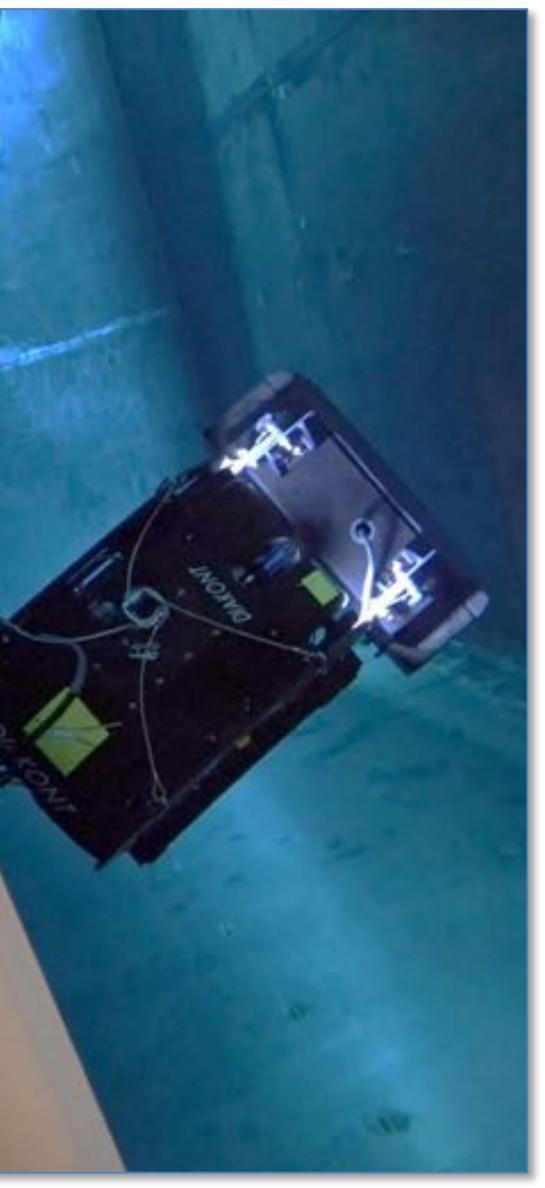
- Decontaminated floors, walls, and curved drywell head
- Cleaning brush operated at various speeds for different sections
 - Slower speeds used for areas with high levels of debris to avoid excessively disturbing the material
 - Process monitored to ensure vacuum captured all dislodged material

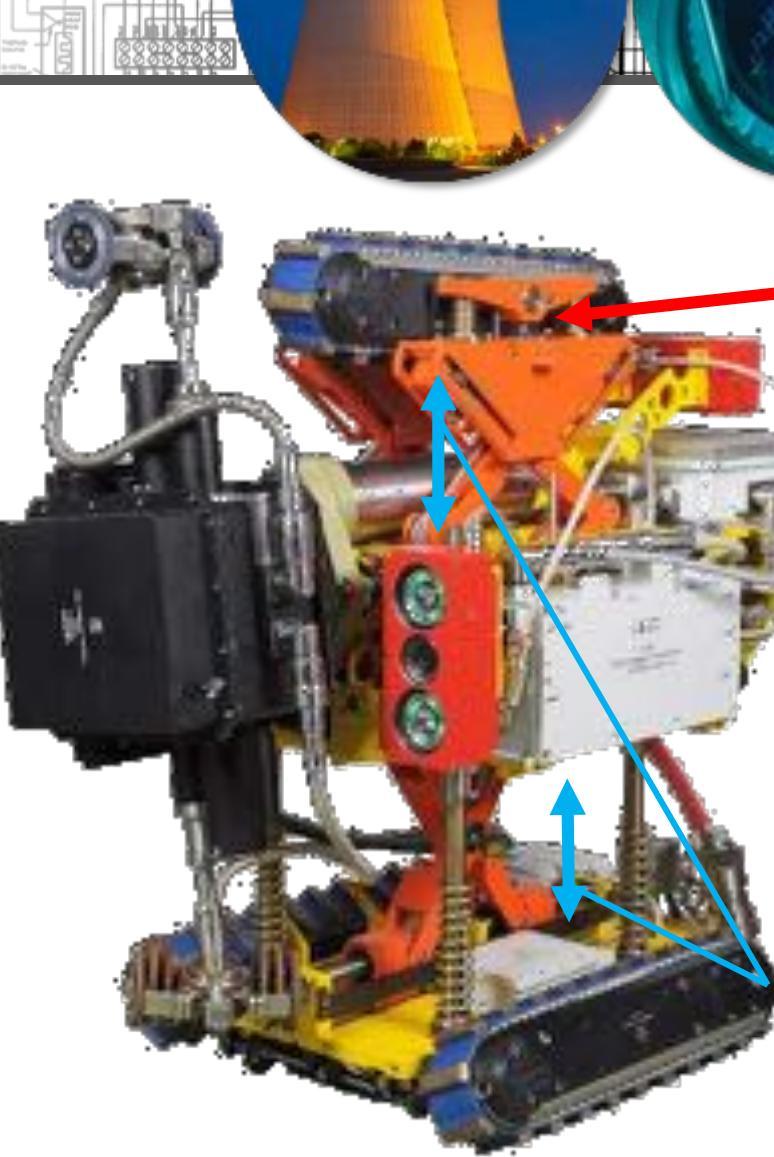
Upper Track – Raises up and presses on the top of the pipe

Robot's center of gravity raises up to accommodate multiple pipe diameters without exiting pipe

- Self-propelled robotic crawler for inspecting buried pipelines
- Driven by robot operator in real time
- Robust track system presses into ID of pipe for traction and vertical navigation
- Able to navigate:
 - Vertical Sections (90 degrees up or down)
 - Unbarred tees / Horizontal tees
 - Inclines and declines
 - 90 degree bends
 - Back-to-back bends
 - Reducers

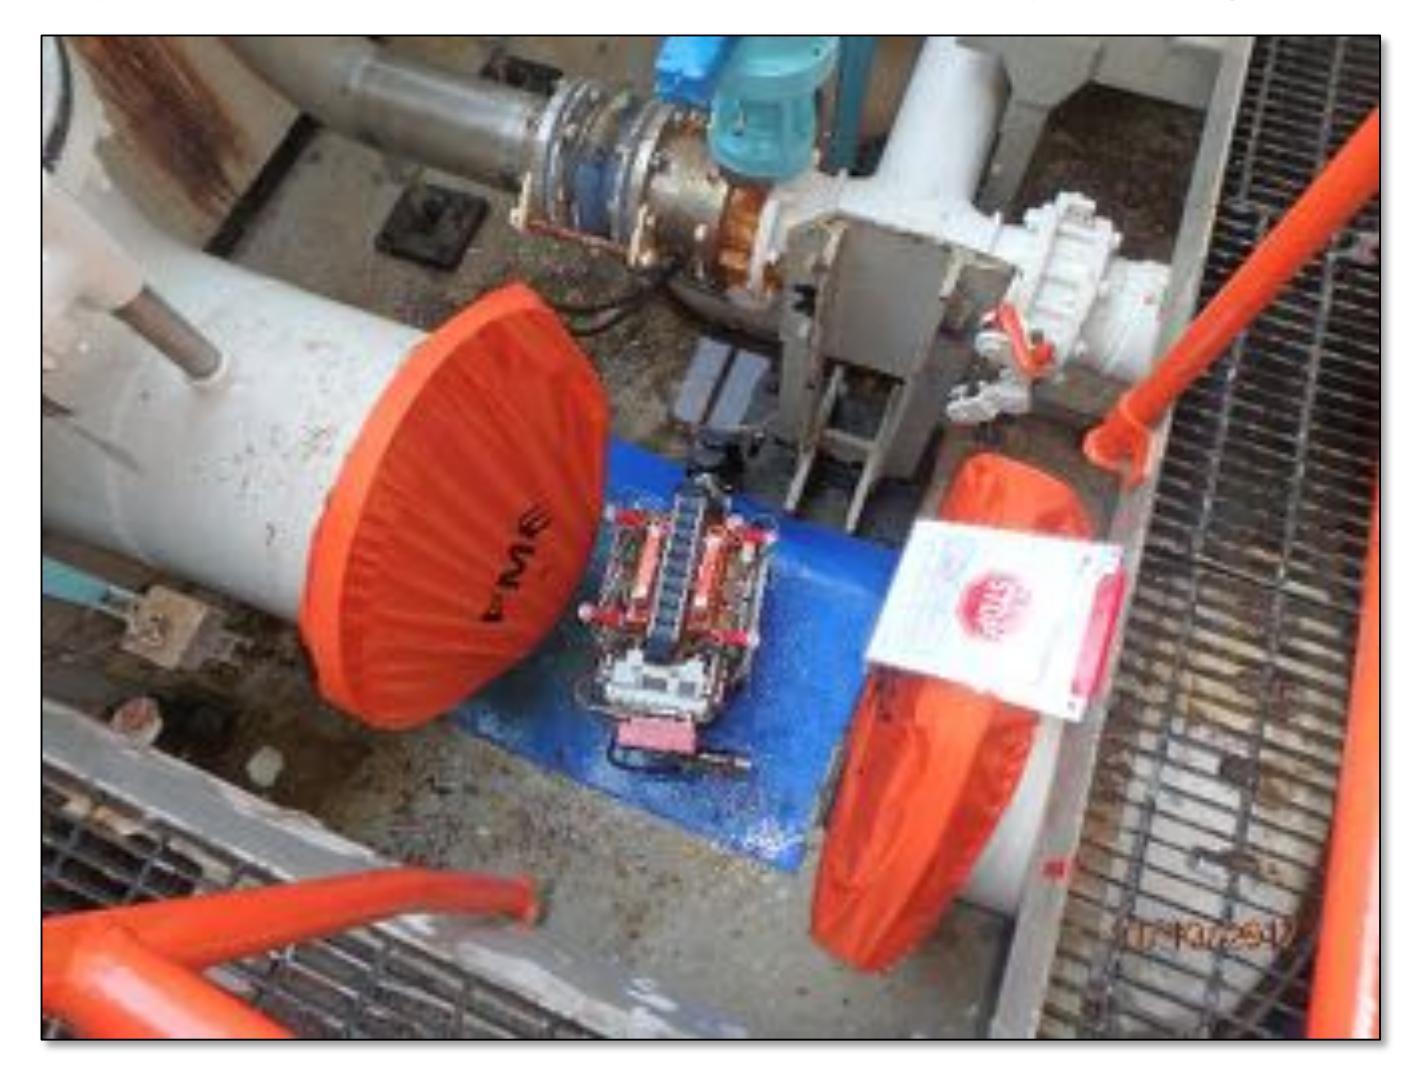
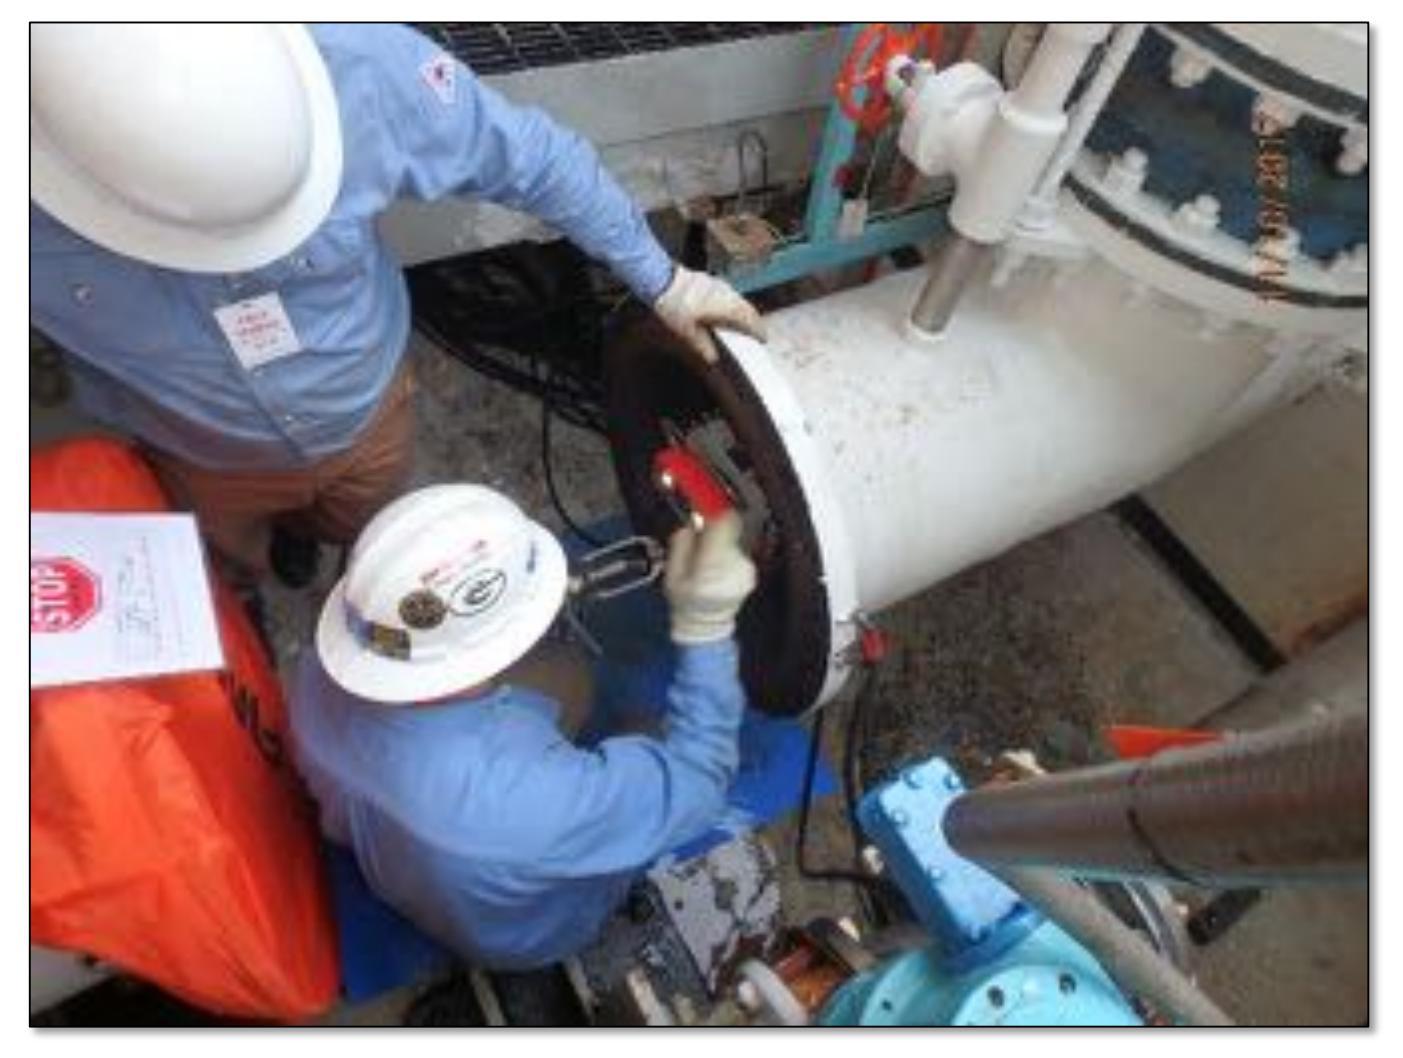
Access Point

Operator removed valve for opening.

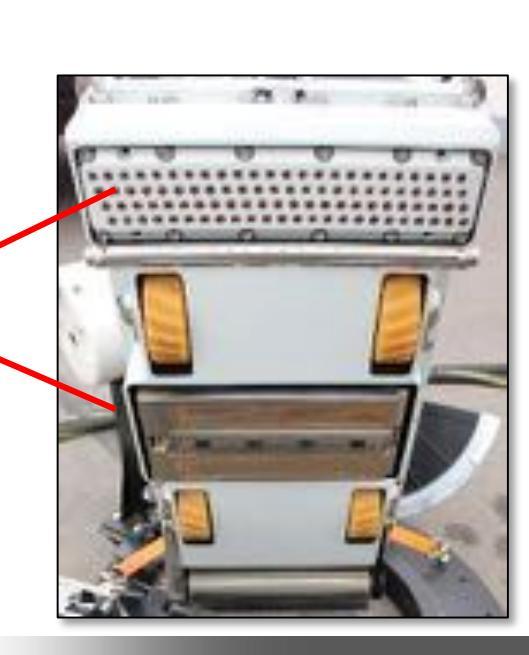
Utilizes a combination of MFL for detection, and a 96element UT array for sizing

- Class 1 Div. 1 system
- Complete NDE coverage, including annular ring critical area
- Motorized brush and plow for sludge displacement
- Real-time automated tank floor mapping
- 3D imaging sonars for obstacle avoidance
- Fail-safe redundancy and emergency retrieval features

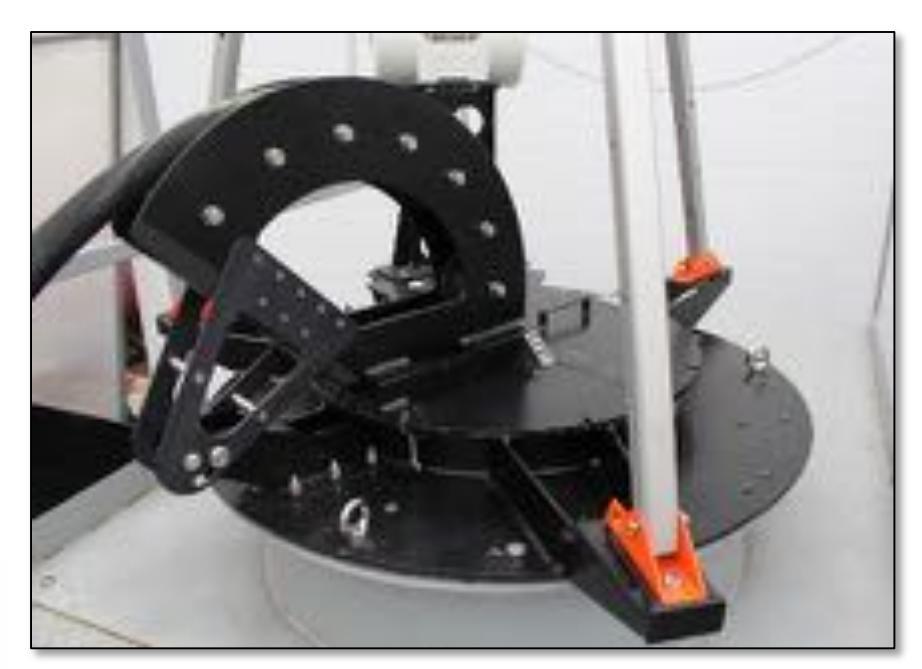
Hatch seal with vapor seal for umbilical cable

- Temporary hatch fitted in place of manway blind following roof launch
- Cable seals to block VOC emissions
- Environmental basin fastened around manway during robot recovery

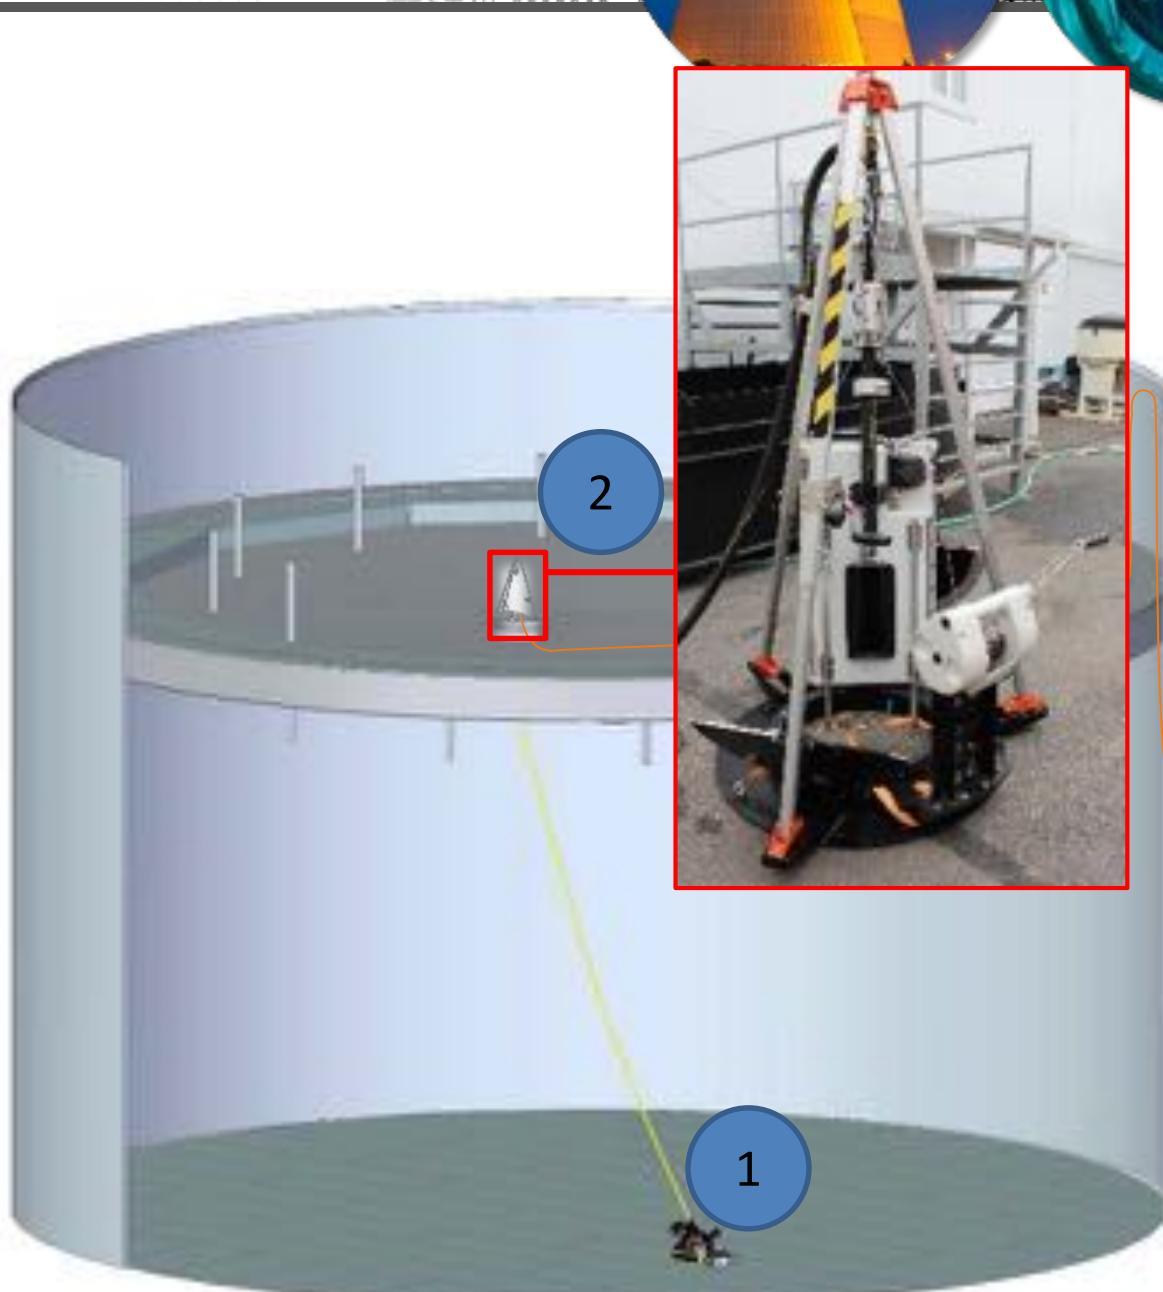
1) Inspection tool 2) Deployment module 3) Operation vehicle (outside berm)
